INTERNAL SUPPORT TESTING IN ACCORDANCE WITH THE BRITISH STANDARD EN 1993-1-3:2006

DOCUMENT REFERENCE: DR-5897 PROJECT FILE REFERENCE: P10313

Document Title	P10313 – DR-5897 – Internal Support Testing Report v2.0	
Author Mr. Benjamin Cartwright, Specialist Technical Services (U.K) Limited		
Client	Cladco Profiles Ltd.	
Document Status	First Draft for Issue

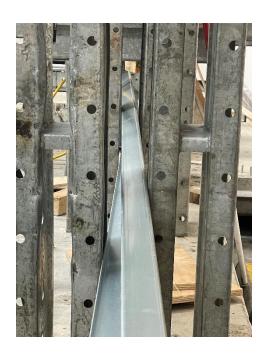
Figure 1 – C Purlin Failure

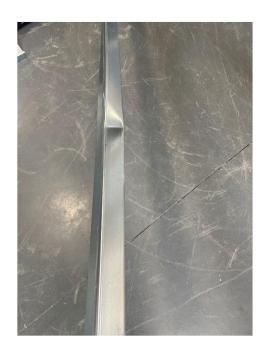
Figure 2 – Z Purlin Failure

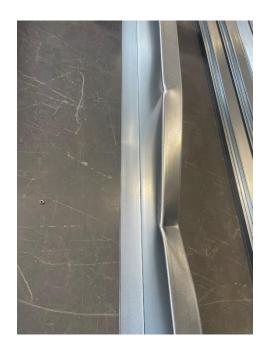
Figure 3 – C Purlin Failure

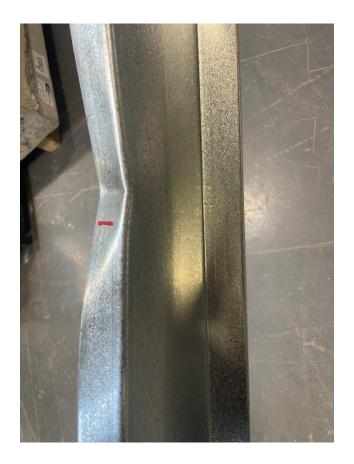
Figure 4 – Z Purlin Failure

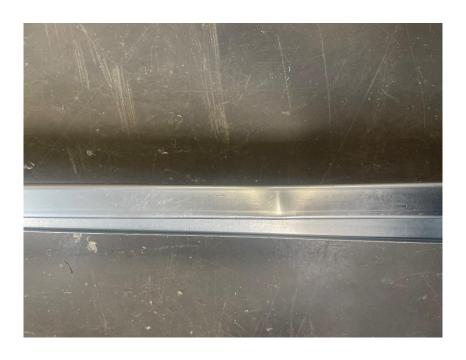
Figure 5 – Z Purlin Failure
