# Cladco Profiles Ltd.

## C AND Z PURLIN SUPPORT TESTING

**DOCUMENT REFERENCE: DR-5974**  
**PROJECT FILE REFERENCE: P10313**

| Document Title | <b>P10313 – DR-5974 – Internal Support Testing Report v1.0</b> |

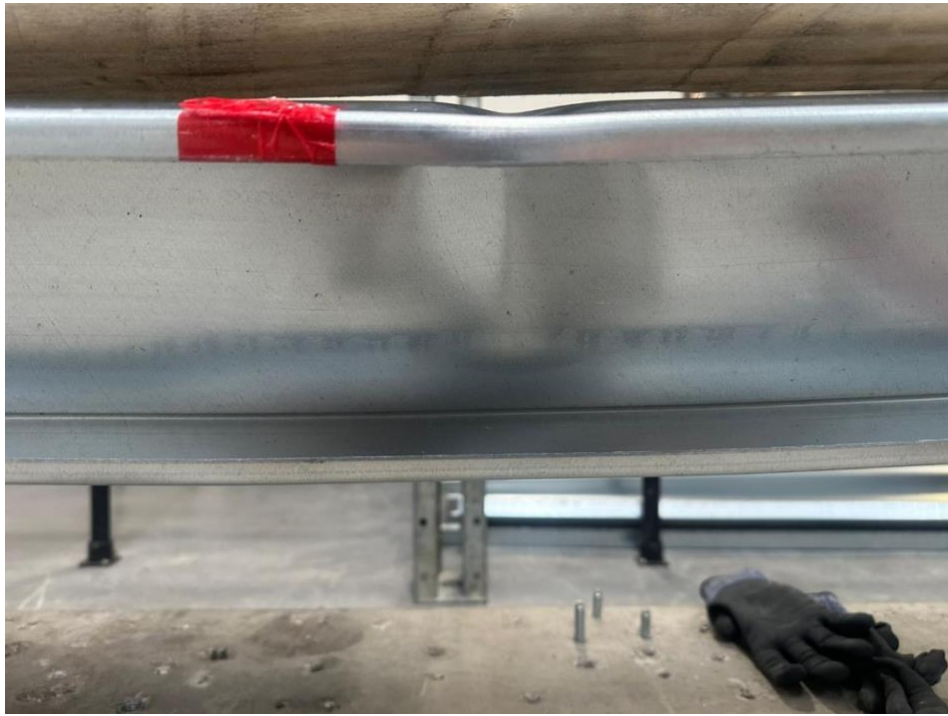
*Figure 1 – C Perlin Failure*

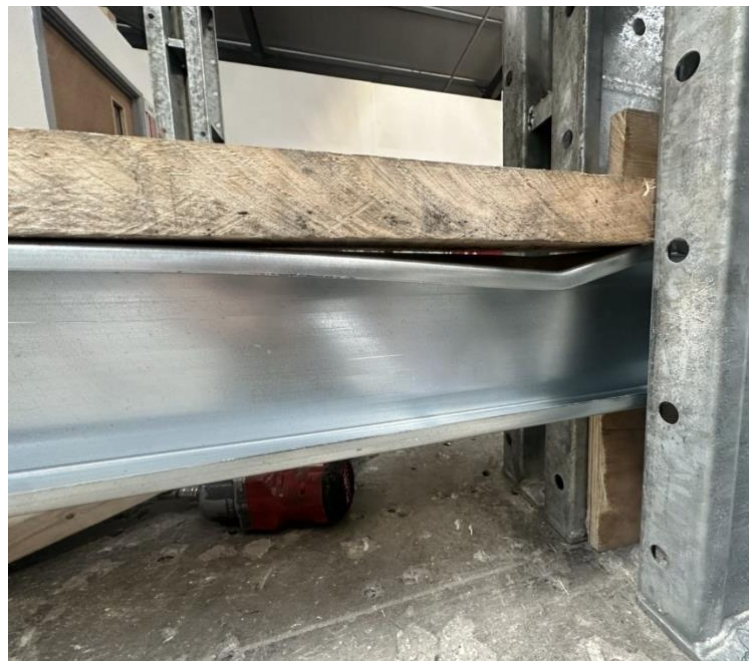
*Figure 2 – Z Perlin Failure*

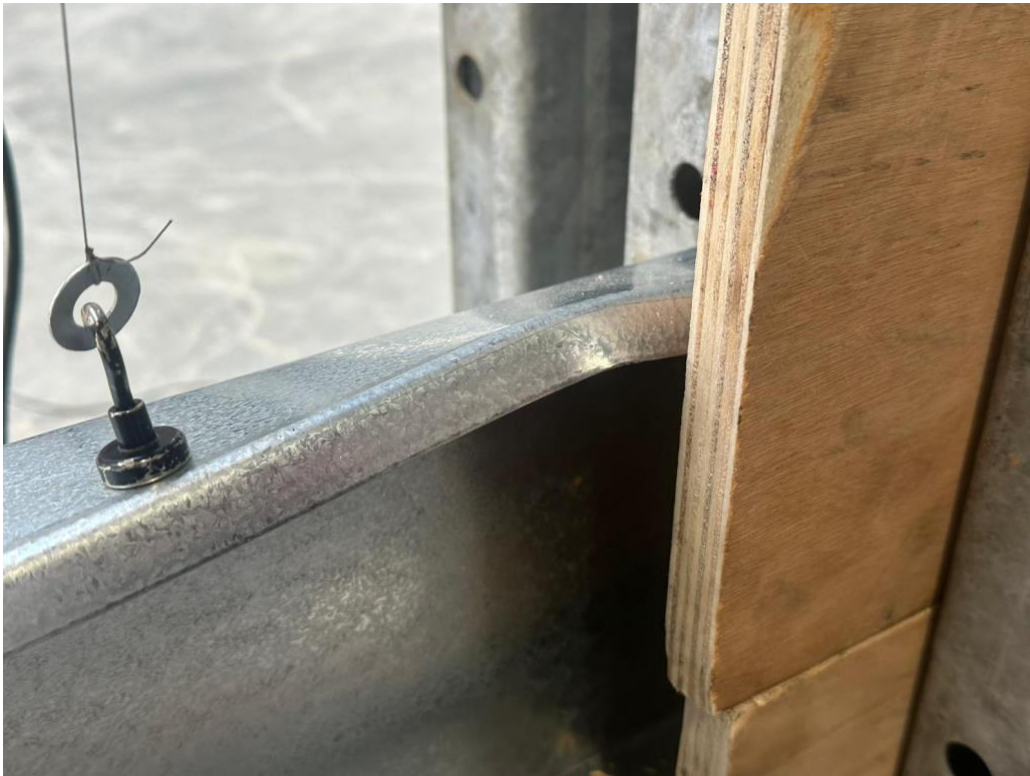
*Figure 3 – C Perlin Failure*

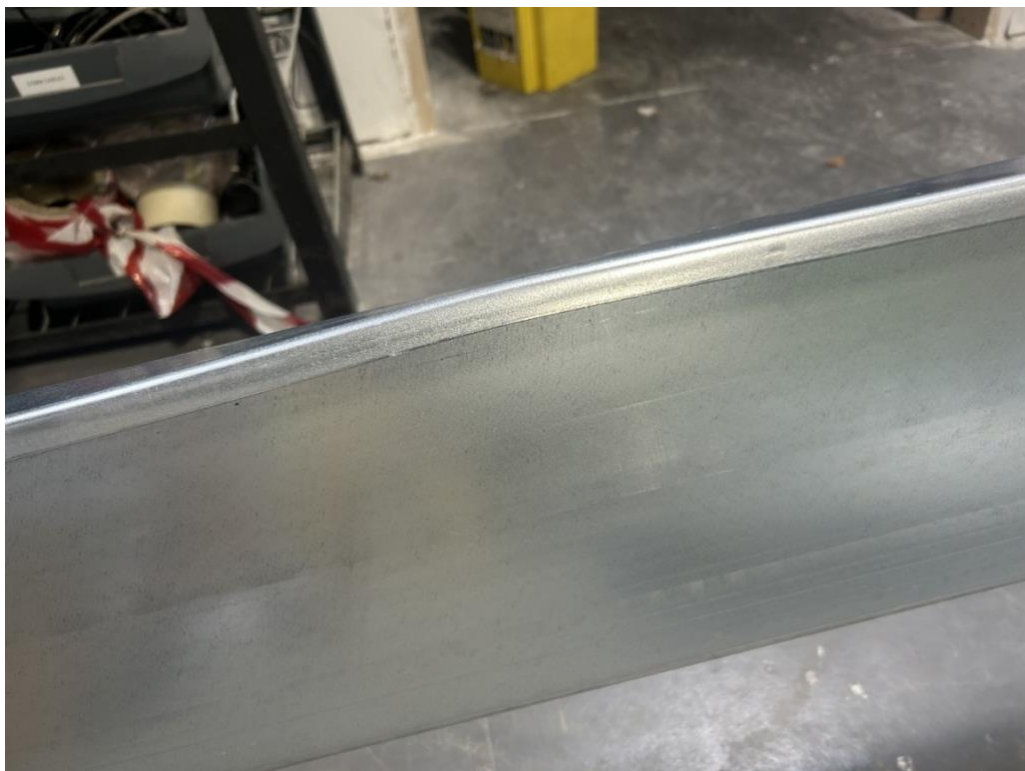
*Figure 4 – Z Perlin Failure*

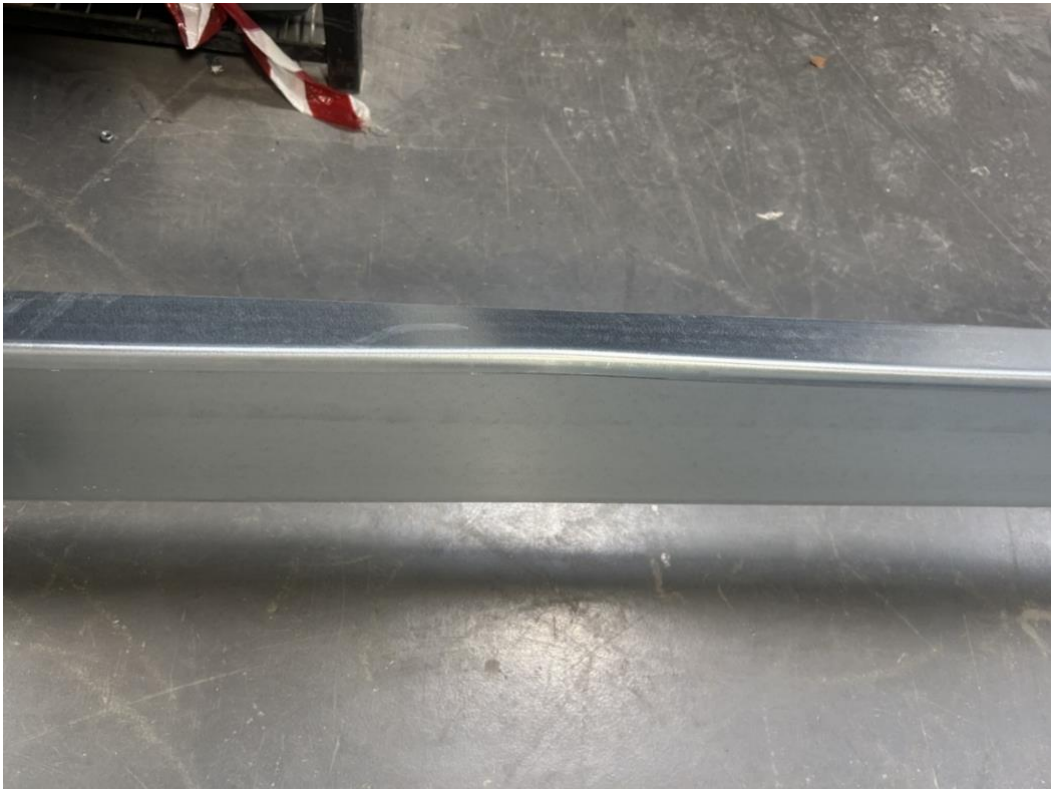
*Figure 5 – Z Perlin Failure*

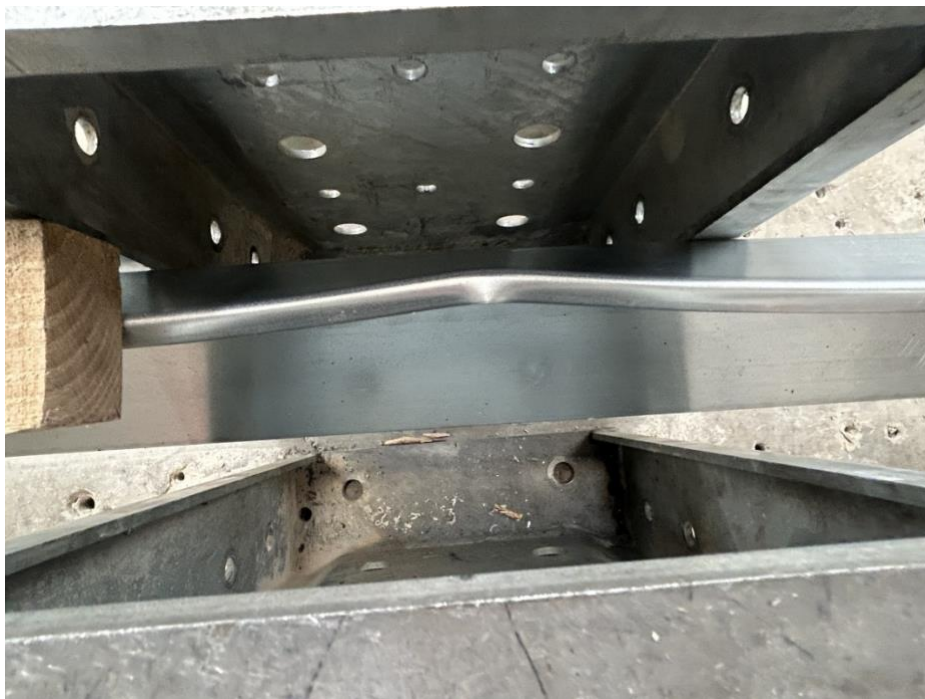
*Figure 6 – Z Perlin Failure*
